No Survivors

A fishing vessel meets a mysterious end in the Bering Sea.

Lessons Learned

from **Casualty Investigations**

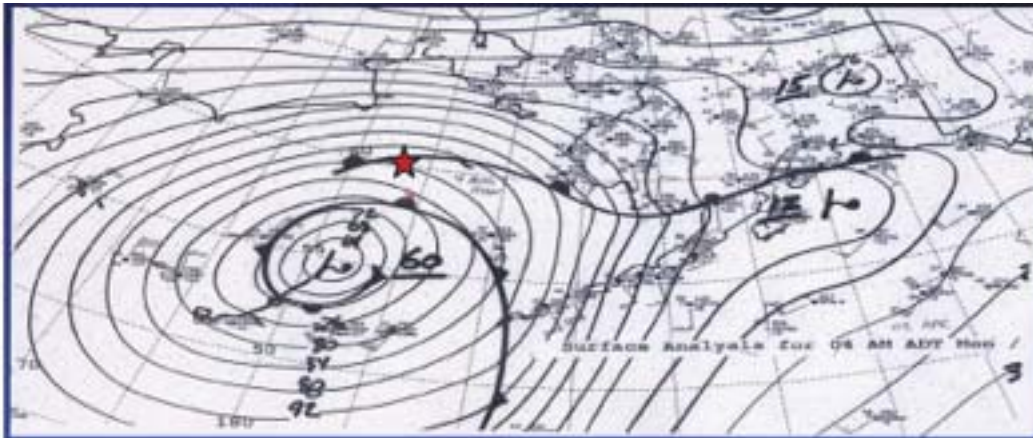
weather event called a “triple point” occurred at the vessel’s last known position. This is an area of a frontal system where a cold, warm, and occluded front join together, and is usually associated with severe weather. It is likely, based on the triple point, that the vessel experienced these three distinct weather patterns in a short period of time.

National Weather Service surface analysis for 4 a.m. on April 2, 2001. The red star indicates the approximate position of the Arctic Rose. Graphic courtesy of the National Weather Service.

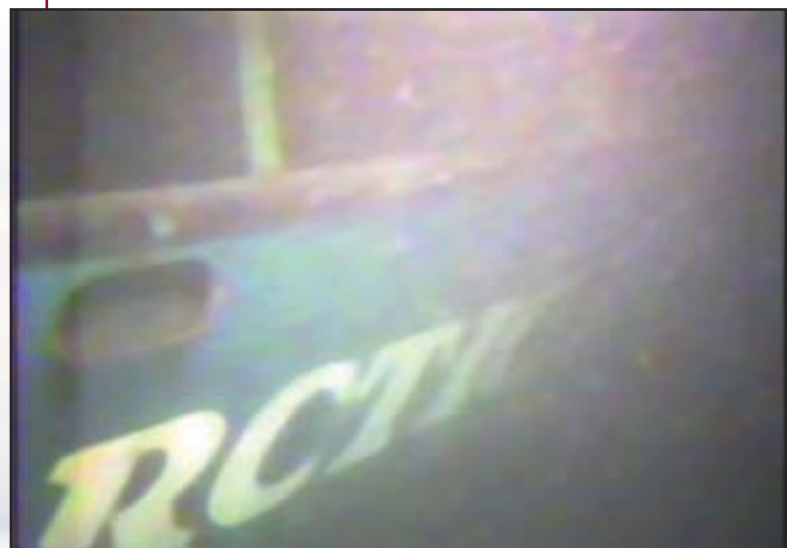
Photograph of the Arctic Rose taken during the remote operated vehicle expedition. U.S. Coast Guard graphic.

- The hull of the vessel was intact.
- The pilothouse was undamaged and all visible windows were intact.
- The rudder was hard to port.
- The trawl doors were missing and the trawl net was on the reel with the cod end in the dump box.
- The starboard overboard chute was partially open.
- Wires were spooled on the trawl winches and trawl gear, wires, and mud lines had shifted to starboard.
- Plow marks aft, where the vessel's Kort nozzle made its initial impact, indicate that the vessel landed on the sea floor, stern first.
- There was no evidence of explosion or fire.
- The vessel was not fishing at the time the casualty occurred.
