This report complies with the U.S. Coast Guard (USCG) and Maritime Transportation Act of 2004 (P.L. 108-293), which directs that “not later than 180 days after the date of the enactment of this Act, the Secretary of the department in which the USCG is operating shall study and report to the Congress regarding measures that should be taken to increase the likelihood of survival of passengers on small passenger vessels who may be in the water resulting from the capsizing of, sinking of, or other marine casualty involving the small passenger vessel. The study shall include a review of the adequacy of existing measures.”

Measures to keep passengers out of the water

Measures for safe egress of persons wearing Personal Flotation Devices

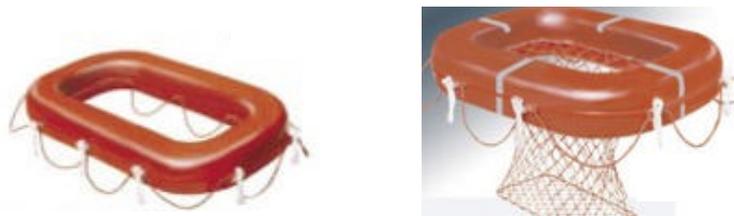
Prior to 1996, the last major revision to the small passenger vessel regulations was in 1963. The lifesaving requirements for small passenger vessels were based exclusively on buoyant apparatus⁴ and life floats (see fig. 2) as survival craft. These two devices, which have been in use on commercial vessels for at least 70 years, are similar in that they are both like very large life rings. The primary difference is that a life float includes a platform suspended from the buoyant portion of the device by netting or similar means. Neither device supports a person out of the water; with the exception of a few persons who might be able to stand on the platform in the center of a life float and only be immersed waist-deep, they generally only provide something for persons in the water to hold on to, with most of the rated capacity hanging on the outside edge.

Figure 2. Rigid buoyant apparatus (left) vs life float (right)

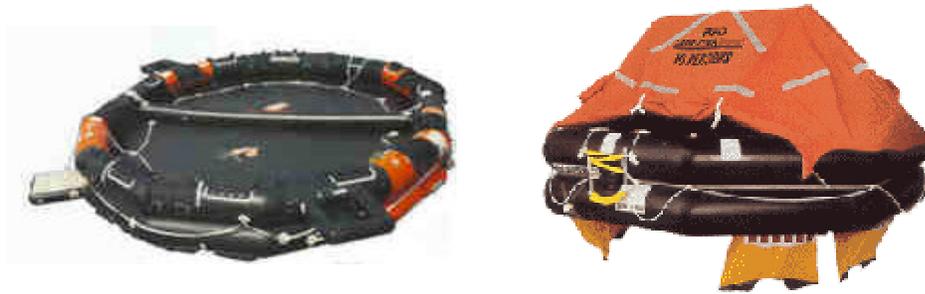
For those vessels at highest risk, the SNPRM proposed carriage of inflatable survival craft. Such survival craft include "inflatable buoyant apparatus" and inflatable liferafts. The two are structurally very similar; however the inflatable liferaft provides better protection from the elements as it is equipped with a canopy to protect the occupants from wind and waves, and the floor is insulated. On the other hand, because the top of an inflatable buoyant apparatus is open, it has the demonstrated potential of carrying up to 50% over its rated capacity while remaining a viable survival craft in calm seas. It is also well suited to vessels with high passenger volumes because its open construction means that it can be boarded faster than an inflatable liferaft which has discrete entrances (see fig. 3).

Figure 3. Inflatable buoyant apparatus (left) vs inflatable liferaft (right)

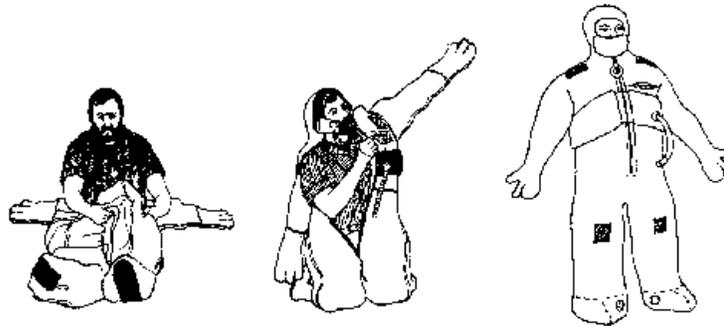
required, and the potential for panic and confusion, would likely only exacerbate the situation. In addition, in a case where persons are in the water before they can don any protective gear, an untrained person is far more likely to be able to don a lifejacket in the water than an immersion suit (although it is likely that neither would be easy) (see fig. 4).

Figure 4. Donning a typical immersion suit.

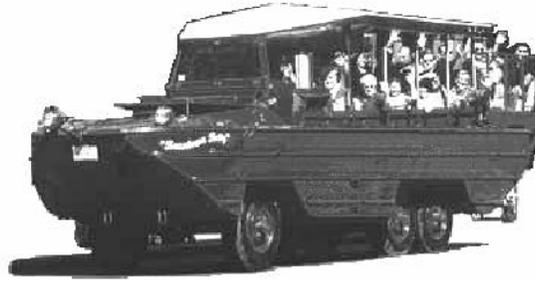
The only reported casualty where egress of persons wearing personal flotation devices has been a significant issue was the 1999 sinking of the Coast Guard inspected small passenger vessel MISS MAJESTIC. On May 1, 1999, the MISS MAJESTIC (a “DUKW” amphibious vehicle, originally designed as a World War II military transport) rapidly sank in 60 feet of water about 250 yards from shore in Lake Hamilton, near Hot Springs, Arkansas. Flooding of the vehicle was not apparent to those on board before downflooding over the stern became imminent. The vehicle sank in less than 30 seconds after the master recognized the vehicle was in distress. The master and seven of the twenty passengers escaped from the vehicle after it sank, and made it to the surface alive. Thirteen of the twenty passengers drowned. A Marine Board of Investigation determined the cause of the casualty to be “unchecked flooding ... resulting from the aft shaft boot seal dislodging from the shaft housing at the start of waterborne operation.” It also revealed a serious problem with the method of egress from the vessel. MISS MAJESTIC sank rapidly stern first forcing the passengers into the canopy and toward the windshield. The windshield was locked in the up position and the canopy came to the top of the windshield. Further, vinyl side windows had been installed to the sides of the windshield. The passengers were trapped.

Figure 5. DUKW modified for small passenger vessel service

that the passenger can adequately egress the vehicle. The window framing vertical distance should be sufficient for a passenger to exit while wearing a lifejacket, with a recommended vertical distance of 32 inches from gunwale to canopy. Overhead storage of lifejackets should not impede the egress of passengers. Finally, the NVIC provided guidance regarding deck rail heights to ensure that they do not unduly hamper egress over the side.
